A GUIDE
TO
EROSION REDUCTION
ON
NATIONAL FOREST
TIMBER SALE AREAS

U.S. FOREST SERVICE
CALIFORNIA REGION
1954

R. P. McRorey California Region
N. F. Meadowcroft California Region
C. J. Kraebel California Forest and
 Range Experiment Station

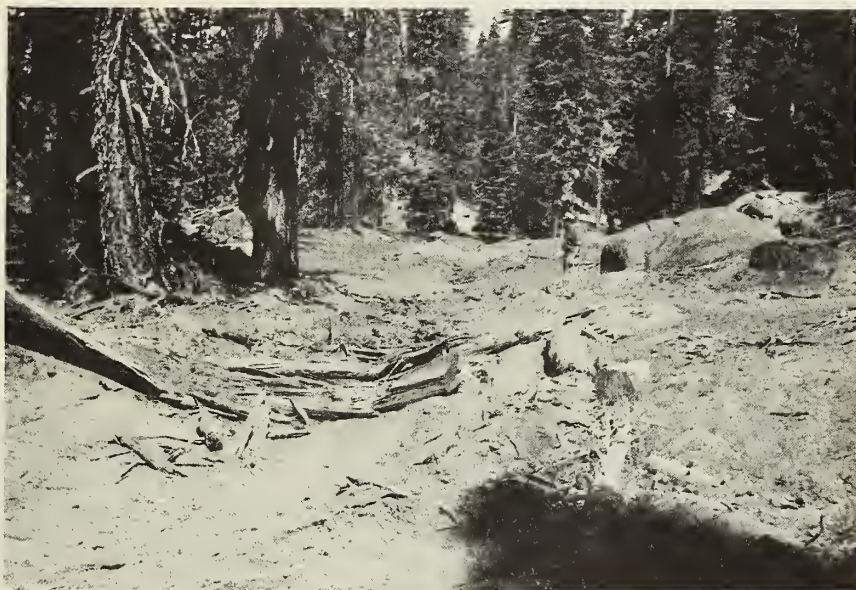
76.

Temporary road protected from erosion after logging by felling a partly rotted snag, and placing slash in the roadway. Good contact with ground was obtained by passing tractor over the fallen snag and slash after placement.

- d. Where natural revegetation of an abandoned road will be slow, it is sometimes advisable to scarify the roadbed and seed or plant with trees. When vegetation is firmly established in the roadbed the erosion problem will be largely cured. Frequently scarifying the roadbed will give enough aid to natural regeneration to complete the job without seeding or planting.
- e. Placing slash or other debris in close contact with the abandoned roadbed will impede the flow of water and reduce erosion. This treatment is especially good when, because of road location, it is difficult to construct water-breaks as frequently as desirable to prevent erosion. Picture 76 shows an example of this treatment.

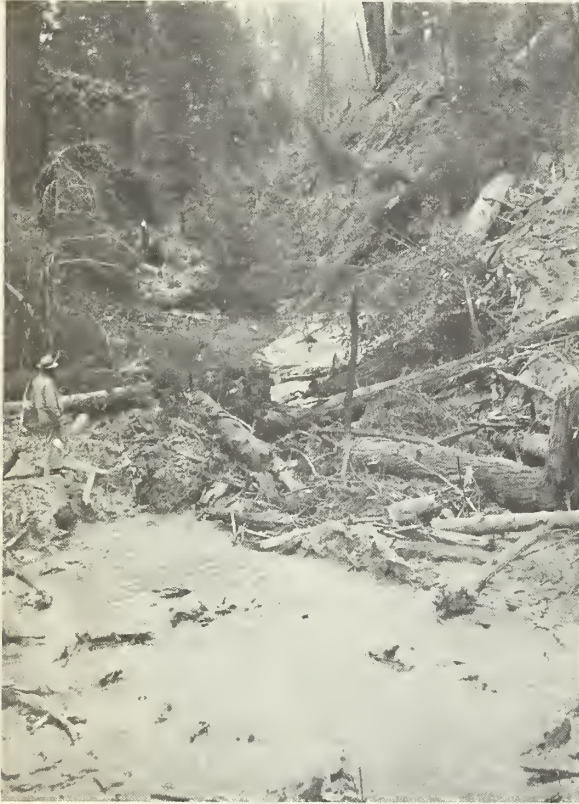
77.

Slash barriers in this stream have stopped the circulation of fish; erosion deposits have killed their food and covered their gravel spawning beds; removal of stream-side shade trees has admitted full sun to warm the shoaled water above optimum temperatures for trout. Result: a nearly dead trout stream.

Spring floods may open some of the barriers, or pile them into fewer and higher "dams," and streamside trees will grow again. But, unless the barriers are removed by man, it will be many years before this stream becomes once more a suitable environment for trout.

When the foregoing methods of logging and road construction are neglected, the results to watersheds are frequently disastrous and long lasting. Pictures 77 and 78 illustrate some of these unfortunate results.

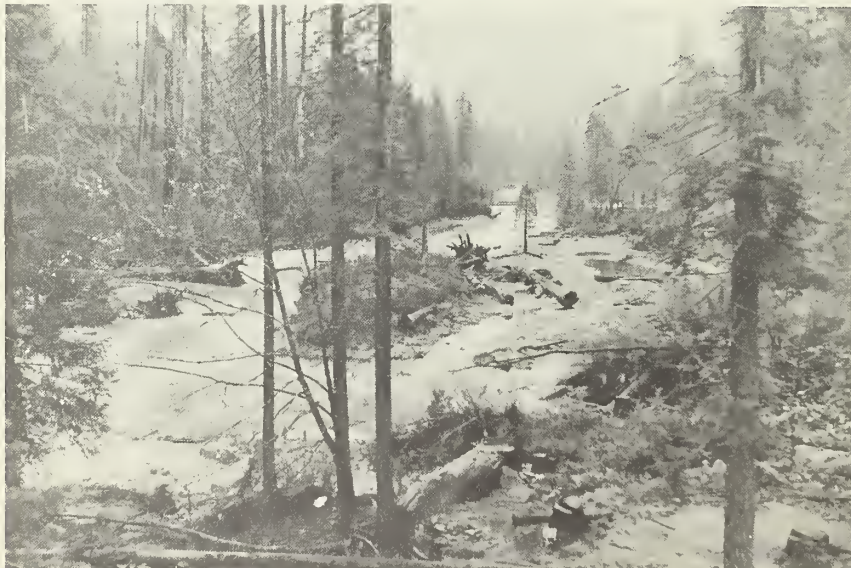
78.

This large stream, once deep and clear, is now heavily choked with sediments and debris from improperly logged areas. Each year during high water much of this material moves down into an irrigation reservoir, a case in which the watershed damages extend far beyond their source.
